WL-TR-96-4013

**LARGE AREA COMPOSITE INSPECTION
SYSTEM LACIS-D**

**FRANK KARPALA, PhD
OMER HAGENIERS, PhD**

FINAL REPORT FOR PERIOD SEPTEMBER 1993 to AUGUST 1995

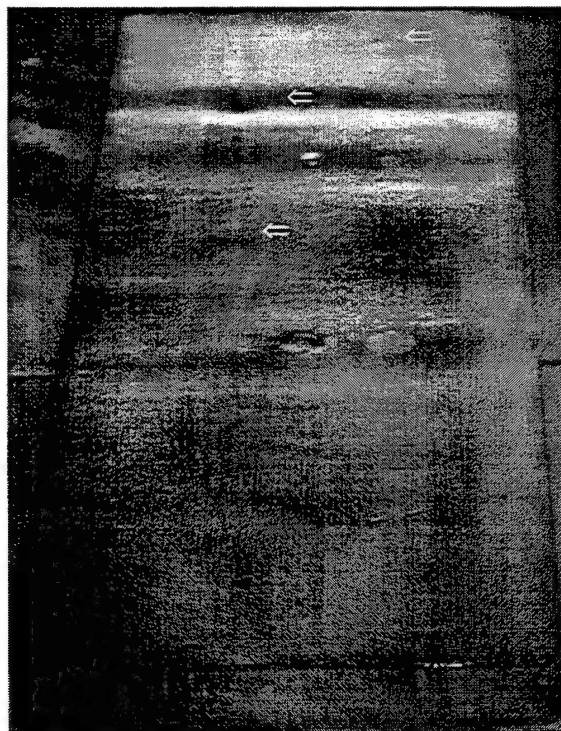
Figure 14: Radome under broad source lighting with suspected indications marked by an arrow

The repairs on the panel can be seen in ambient light, because of differences in color. The "point" source *D SIGHT* setup was very sensitive to the skin waviness but only one site was marked as a possible defect indication. The broad light source setup seemed to be able to pick-up the same indication site plus two other sites. All suspect sites are marked in the *D SIGHT* images shown in **Figure 13** and **Figure 14**.

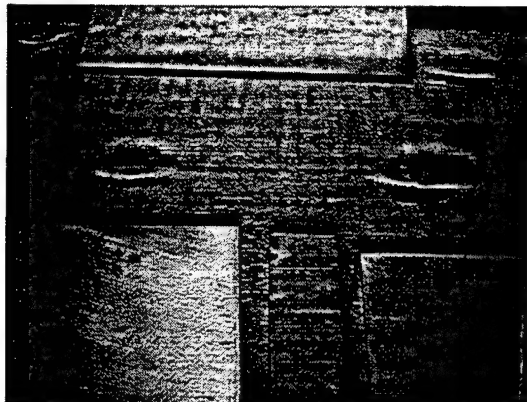
Figure 22: Original DAIS-500 configuration

Figure 22 shows a *D SIGHT* image from a DAIS-500 of a collection of specimens with both impact damage and delaminations. By using a broader light source, the high frequency noise on the composite surfaces is attenuated as shown in **Figure 23**. The signatures of the delaminations are improved with a broader light source and a lower base grazing angle of the camera at 22.5 degrees, shown in **Figure 24**. Unfortunately, the resulting package with this optical configuration is over 1 foot longer than the DAIS-500. To reduce this package size, a wider angle lens was used and part of the field of view was masked off leaving approximately 3 sq ft. **Figure 25** shows the resulting image. This configuration, although better for packaging, suffers from a loss of magnification and spatial resolution. As a compromise, the grazing angle was increased to 27 degrees at 52 inches and the retroreflector was brought closer to the surface at a distance of 22 inches. **Figure 26** shows the resulting image and indicates that there is sufficient sensitivity to both impact damage and delaminations. Although this configuration results in a package that is slightly longer than the DAIS-500, it has a rectangular footprint, good sensitivity to both impact damage and delaminations, and reduced image noise.

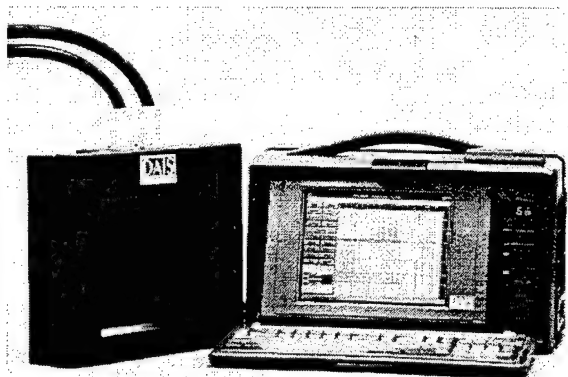
Figure 34: Pendant and Computer Host

The pendant consists of a TFT LCD 10 inch VGA video display monitor with an integral touch screen for user input of control commands. The monitor and cable connectors are packaged in an industrial enclosure with convenient handles. The pendant will provide full control of image acquisition and the ability to display video and system menu items. The new pendant and host computer are shown in **Figure 34**.

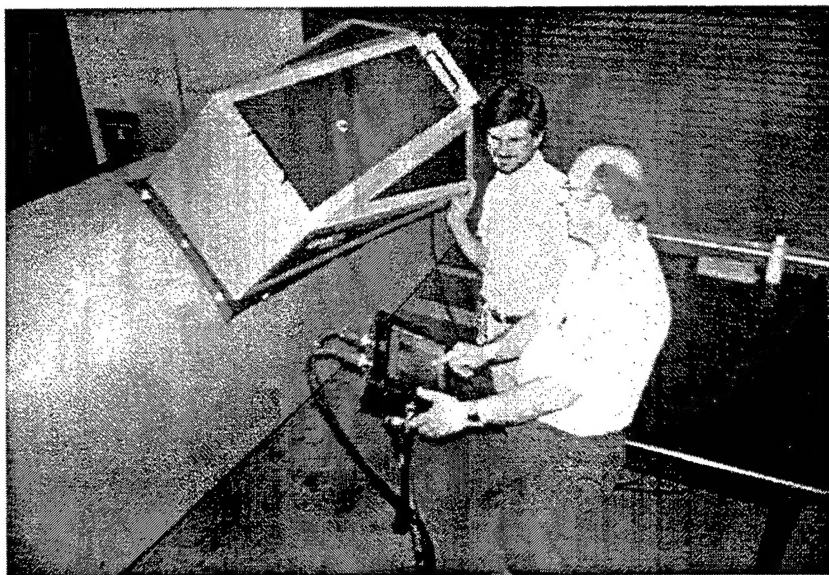
Figure 46: Radome Inspection with DAIS 500

The DAIS-500 was tried on two separate radome sections. Both parts were accessible on the shop floor (see **Figure 46**). The first specimen was constructed of an extremely textured, nonreflective material. As such, a great deal of highlighter fluid was used to acquire the DAIS images from this radome part.

The second radome was smoother and absorbed less light. However, the impact site introduced to the radome surface by Jim Ellison was of an extremely sharp and curt nature - negating the typical broad lipped impact site easily picked up by DAIS imaging.

Both radomes confirmed previous observations that porous, textured surfaces are difficult for the DAIS-500 to inspect.
